# **EPA CHEMICAL ACCIDENT INVESTIGATION REPORT**

## **Tosco Avon Refinery Martinez, California**

EPA550-R-98-009  
November 1998

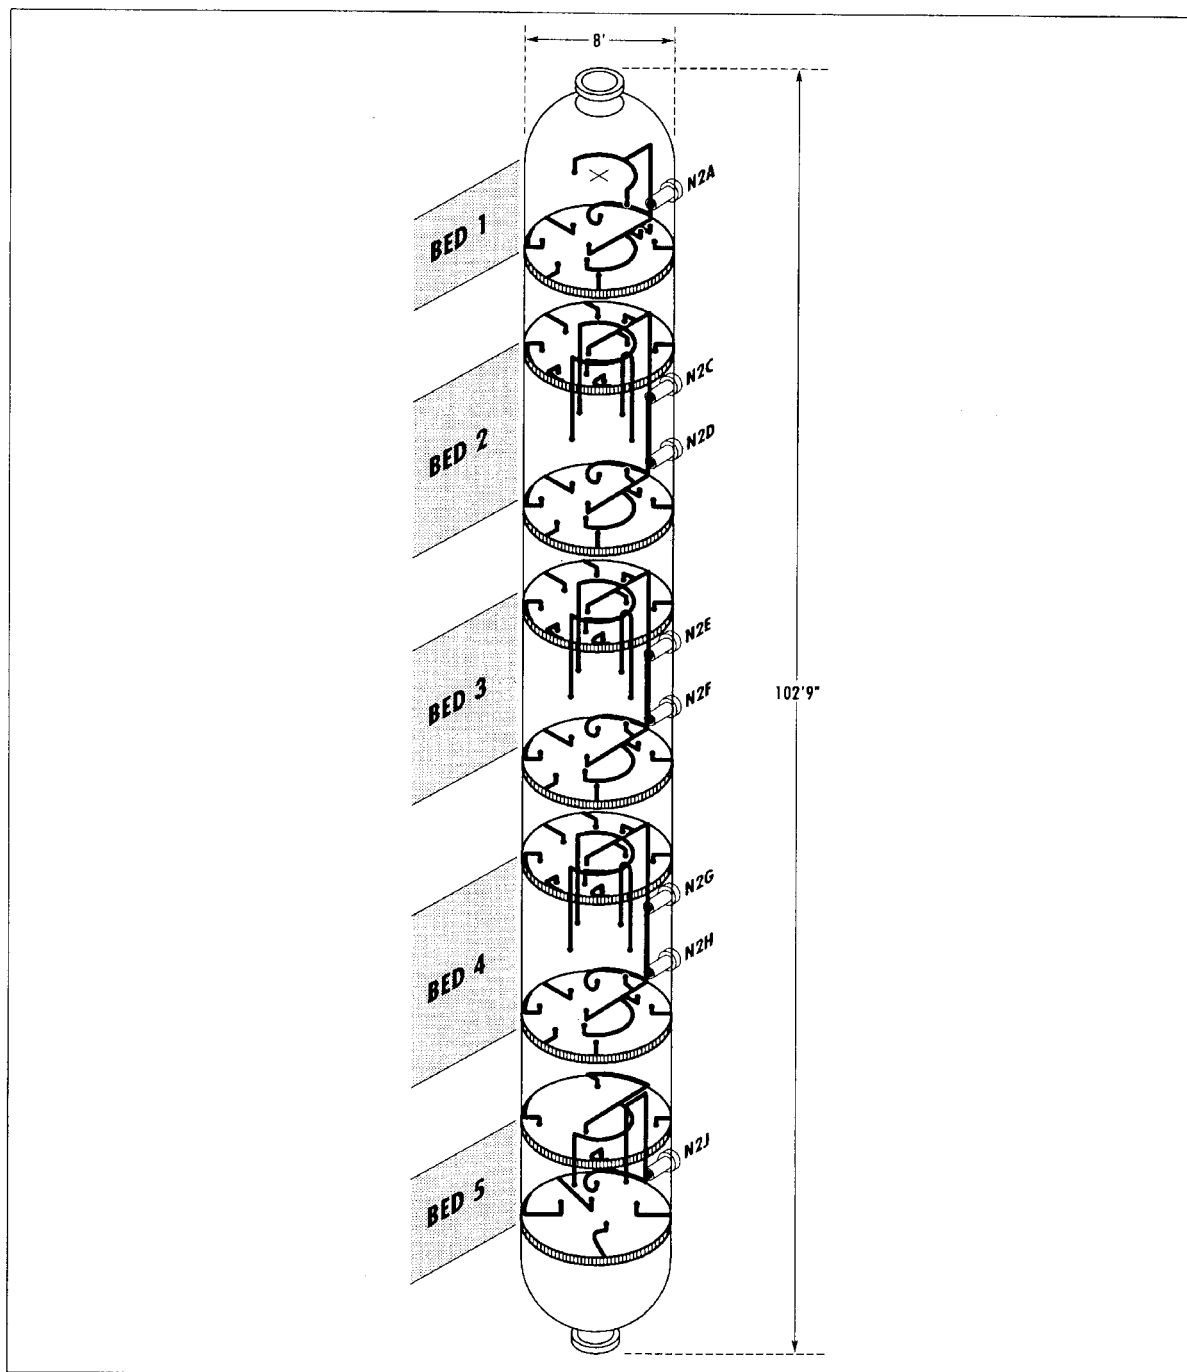
**Figure 5**      **Stage 2 Reactors Thermocouple Arrangement - Isometric Drawing**

were located in each Bed 2 through 4, and twelve were located in Bed 5. Figure 5 shows the location of the internal Stage 2 reactor thermocouples. Additional thermocouples (not shown) monitor the feed, reactor inlet, reactor outlet and reactor skin temperatures (three skin temperatures per reactor).
